# Lessons from Hurricane Katrina Storm Surge on Bridges and Buildings

Ian N. Robertson<sup>1</sup>; H. Ronald Riggs<sup>2</sup>; Solomon C. S. Yim<sup>3</sup>; and Yin Lu Young<sup>4</sup>

**Abstract:** The storm surge associated with Hurricane Katrina caused tremendous damage along the Gulf Coast in Louisiana, Mississippi, and Alabama. Similar damage was observed subsequent to the Indian Ocean tsunami of December 26, 2004. In order to gain a better understanding of the performance of engineered structures subjected to coastal inundation due to tsunami or hurricane storm surge, the writers surveyed damage to bridges, buildings, and other coastal infrastructure subsequent to Hurricane Katrina. Numerous lessons were learned from analysis of the observed damage, and these are reported herein. A number of structures experienced significant structural damage due to storm surge and wave action. Structural members submerged during the inundation were subjected to significant hydrostatic uplift forces due to buoyancy, enhanced by trapped air pockets, and to hydrodynamic uplift forces due to wave action. Any floating or mobile object in the nearshore/onshore areas can become floating debr

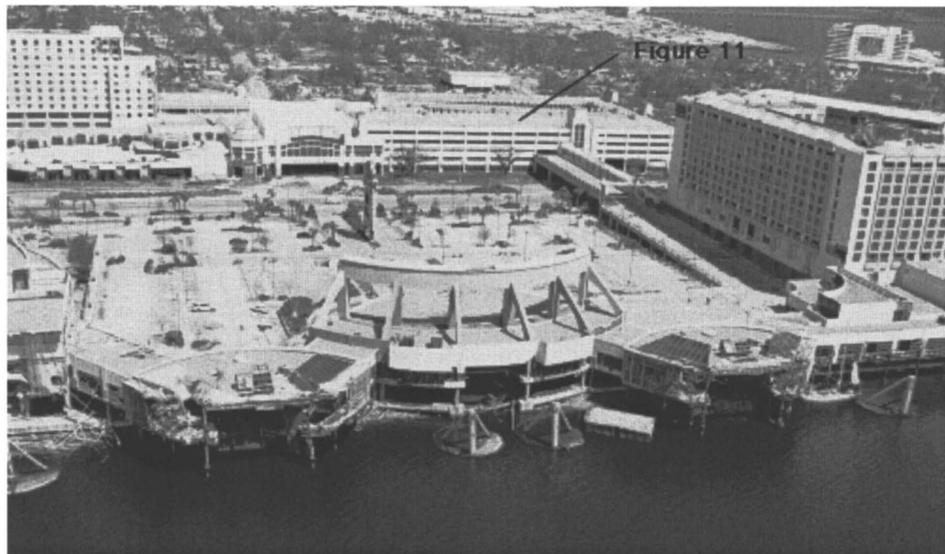
**Fig. 2.** Grand Casino, Biloxi, with inland parking garage that suffered collapse of the second-level double-tee floor system (Fig. 11) (Photo courtesy of U.S. National Oceanic and Atmospheric Administration/Department of Commerce)

(Fig. 2). In these cases, hydrostatic uplift due to buoyancy is likely the major factor causing failure of the slab system.

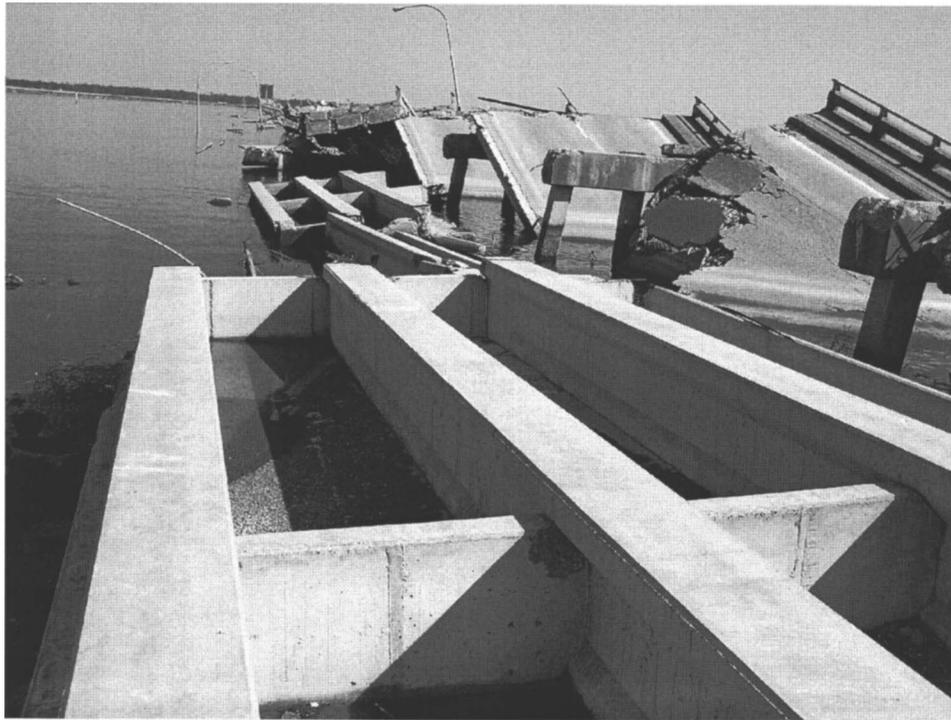
**Fig. 3.** Girders, bridging, and bulkheads potentially trap air below deck of US 90 highway bridge over Biloxi Bay

that these segments were very nearly buoyant once submerged (Fig. 3). Fig. 4 shows the dimensions of a typical cross section of the bridge deck as measured on site, and Fig. 5 outlines the buoyancy calculation performed on this cross section, including the effects of air compressibility.

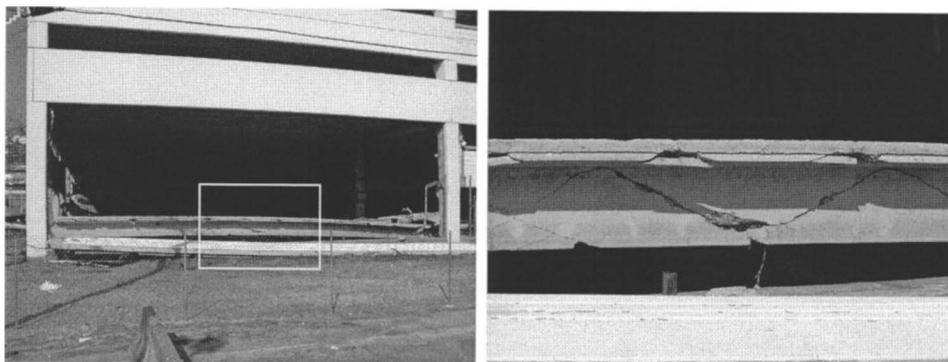
Since the double-tees are designed for gravity load over a simply supported span, they are extremely weak in negative bending. There is typically a light mesh reinforcing in the top flange and topping slab, which are now the tension zone, while the base of the webs is very thin, and the webs now become the compression zone. In addition, the prestressing tendons are located so as to produce uplift intended to balance much of the original unsubmerged dead weight. The combination of uplift due to hydrostatic and prestress effects was sufficient to cause severe cracking of the

webs and top slab and crushing of the concrete at the base of the webs at midspan (Fig. 11). For structures close to the shoreline, wave-induced hydrodynamic uplift and lateral loads would have added to the stress on these sections. In many cases, the negative bending failure resulted in dislocation of the double-tee ends from their supports, resulting in collapse of the floor system.

**Fig. 11.** Double-tee negative bending failure—parking structure in Biloxi

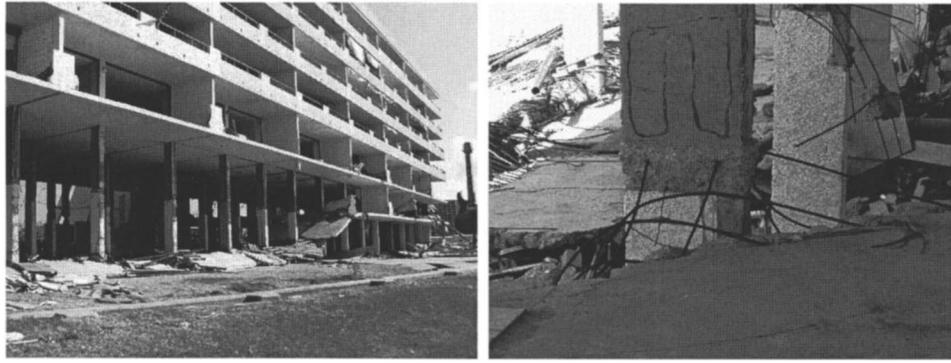
approximately 2.1 m (7 ft), which is within the range required to produce punching shear failure of the slab. This analysis has assumed that the uplift does not induce bending moments at the slab-column connection, which would further reduce the punching shear capacity. In reality such bending moments would exist due to the large cantilever balcony slab protruding toward the ocean.

**Fig. 13.** Flat slab punching shear failure due to hydrodynamic uplift

If these connections had been provided with integrity reinforcement in the form of continuous slab bottom reinforcement passing within the column cage, the total collapse of the floor might have been prevented, even though many of the connections would likely still have suffered punching shear failures. Integrity reinforcement is required by the ACI 318-05 building code for new concrete flat slab construction, but was not required by codes in force when this building was constructed.

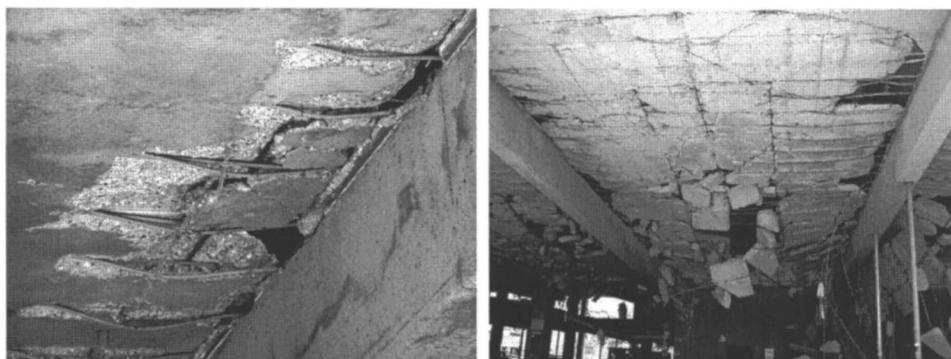
and Casino suffered significant damage and partial collapse of the second-floor bays adjacent to the coastline. It is suspected that hydrodynamic uplift loads on the slab resulted in shear failure of the slab at the supporting beams (Fig. 14) and shear failure at the ends of some of these beams (Fig. 15). The spalling of concrete cover at the epoxy-coated bottom reinforcement in the slab indicates that failure was due to uplift and not downward loads (Fig. 14).

**Fig. 14.** Uplift-induced shear failure of a posttensioned one-way slab

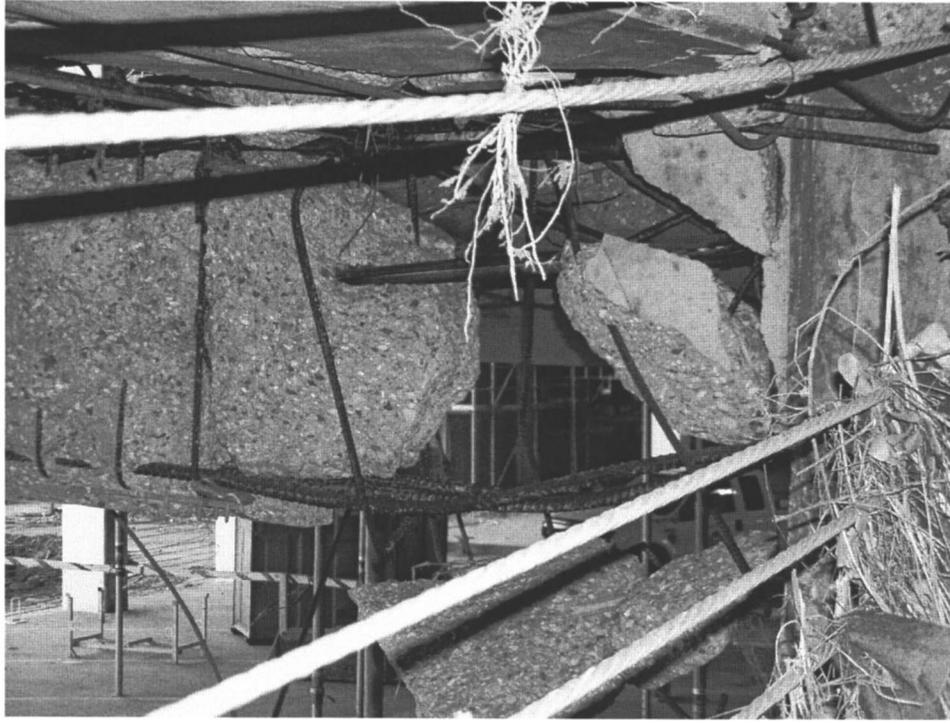
**Fig. 15.** Shear failure of posttensioned beam supporting one-way posttensioned slab

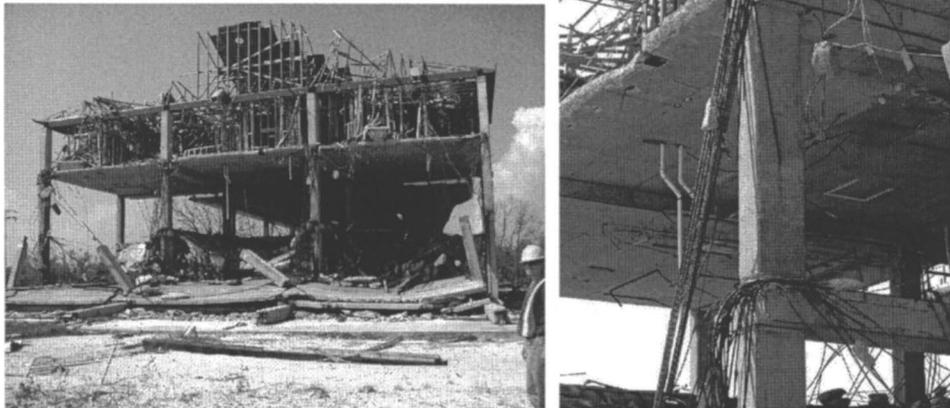
**Fig. 16.** Partial collapse of concrete building frame under construction

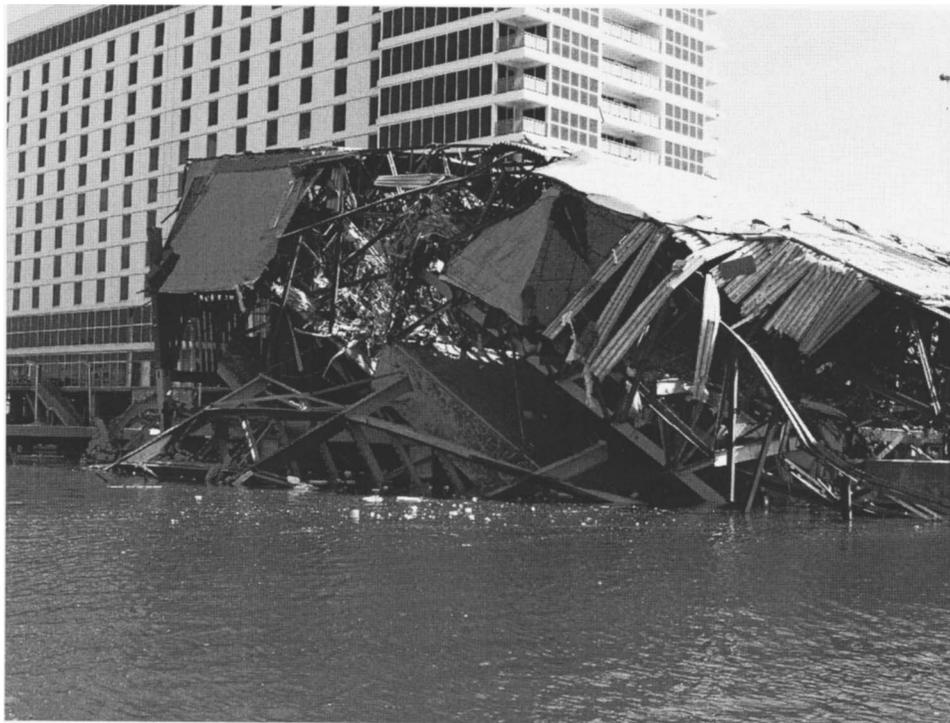
**Fig. 18.** Hard Rock Casino barges enclosed by fixed exterior steel structure

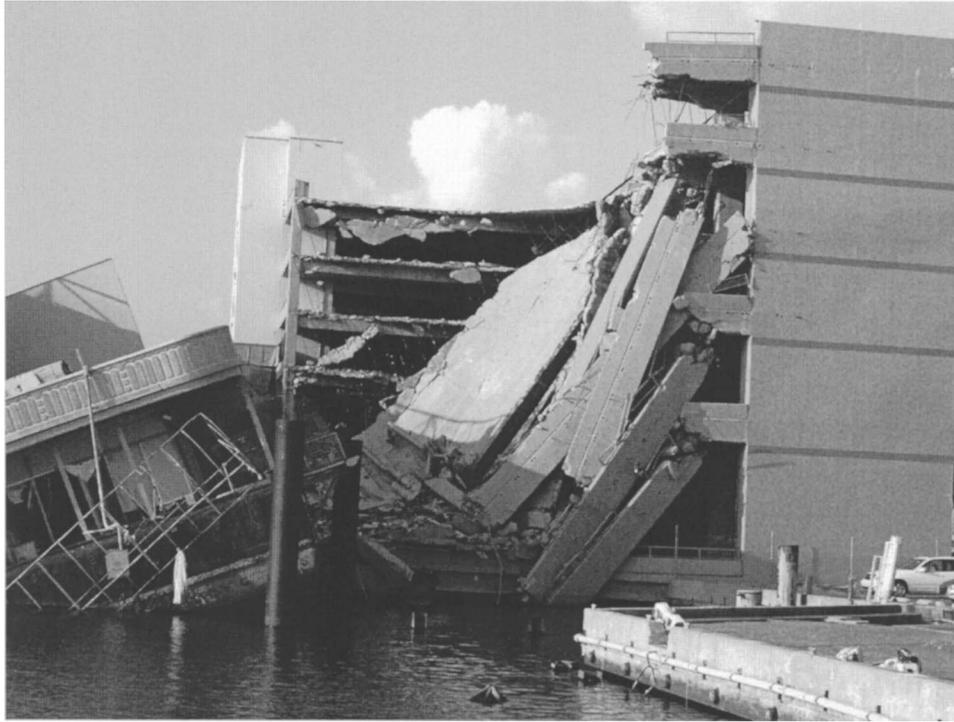
**Fig. 19.** Progressive collapse of parking structure due to barge impact damage to lower-level columns

It is clear that the pounding of the barge-mounted casino on the columns of the parking structure resulted in partial progressive collapse. It is unlikely that the light-frame superstructure could have caused the collapse of the concrete columns. It is more likely that the barge hull, which was located very close to the

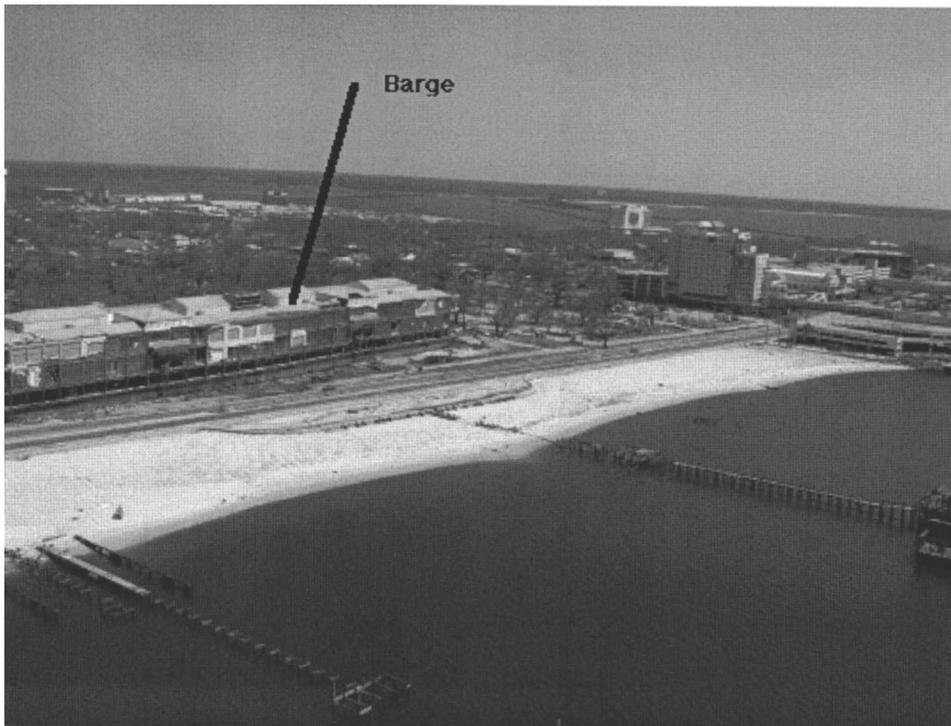
**Fig. 20.** Larger Grand Casino Biloxi barge transported alongshore and inland by Hurricane Katrina (Photo courtesy of U.S. National Oceanic and Atmospheric Administration/Department of Commerce)

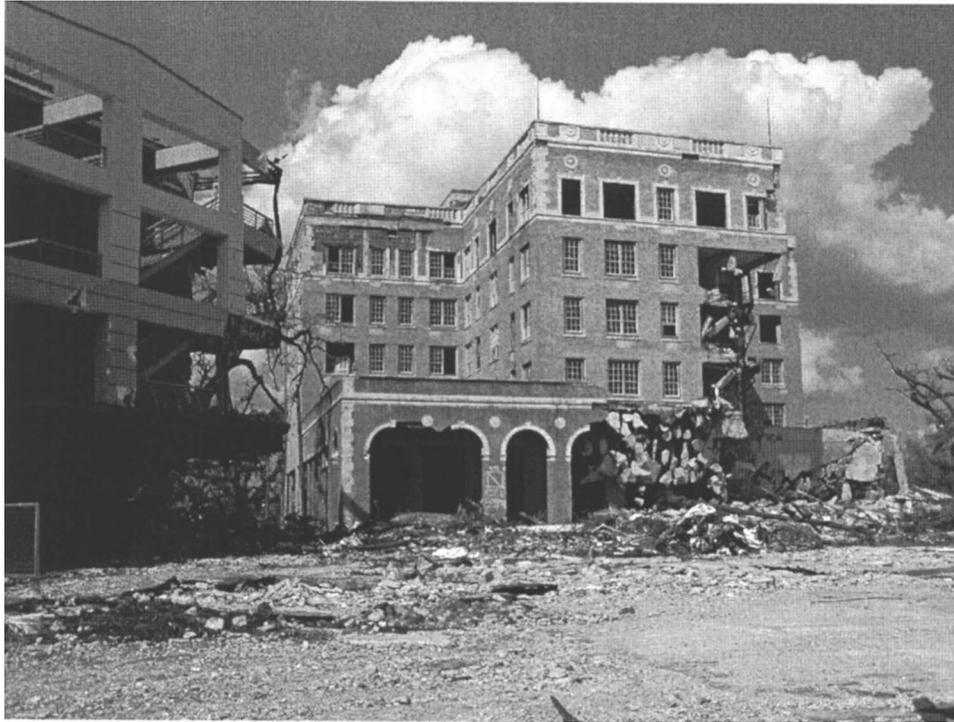
**Fig. 21.** Damage to cast-in-place reinforced concrete building caused by impact of adjacent barge

An example of impact is clearly demonstrated by the collision of the Grand Casino barge with the Tivoli Hotel (Fig. 21). The 2.4 m

is critical to ensure that progressive collapse does not result when a small number of columns or walls are damaged.

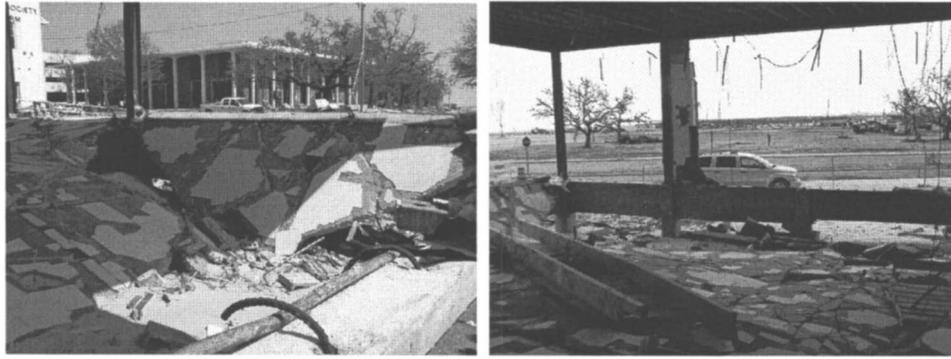
**Fig. 23.** Liquefaction-induced scour under fill-supported first-floor slab

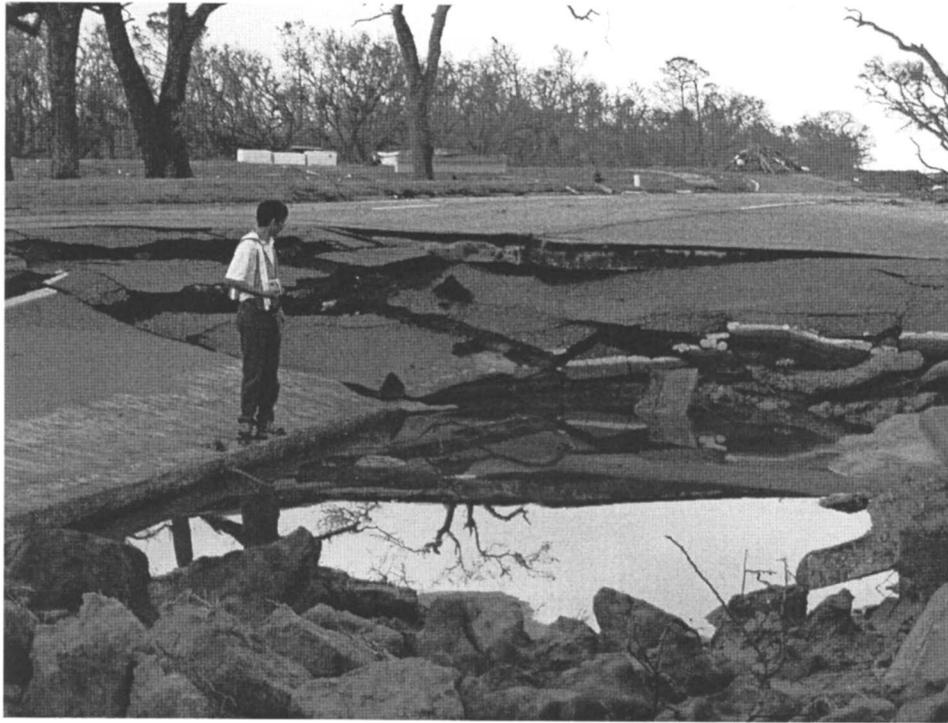
to prevent shear-induced scour and postpone the point at which liquefaction occurs. Nevertheless, the supporting sandy soil or backfill is still susceptible to liquefaction-induced scour, particularly during wave drawdown or ebb surge. Once the supporting soil liquefies and is carried away by the flowing fluid, the thin floor slab or highway pavement, which initially rested on the soil, will collapse, which may eventually lead to total collapse of the structure. Numerous examples of liquefaction-induced scour under floor slabs and footings were observed throughout the Mississippi coastline. Sinkhole-like craters also were observed in many locations along the coastal highways due to drawdown and wave-induced liquefaction of the subgrade below the pavement (Fig. 24).

**Fig. 24.** Sinkhole-like crater left by scour of liquefied subgrade below coastal highway

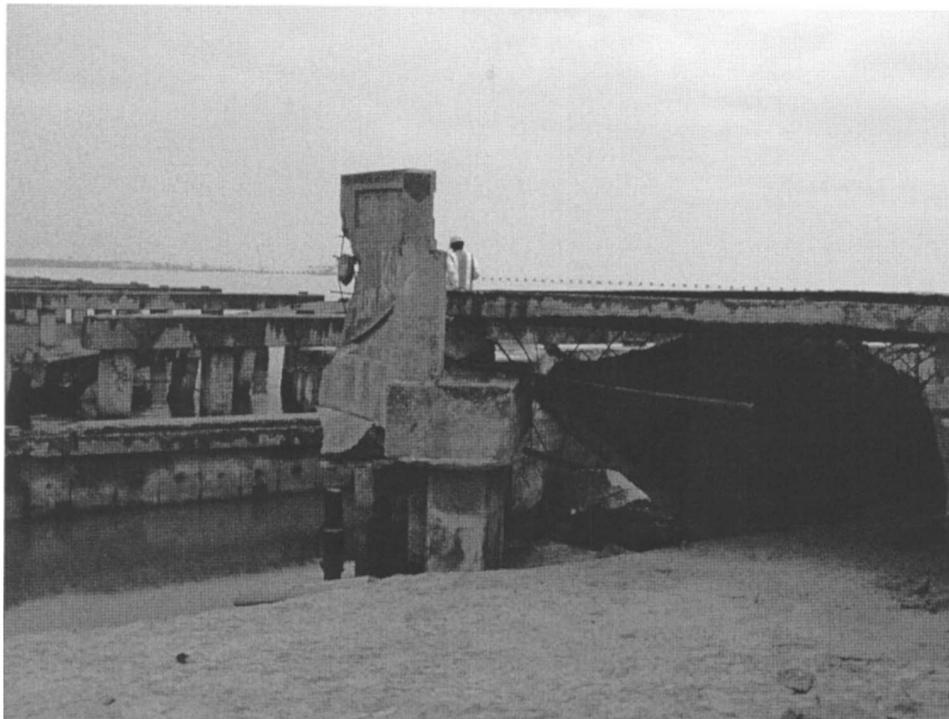
The most extensive scour observed along the Mississippi coastline was at the west-end abutment of the US 90 bridge in the town of Bay St. Louis (Fig. 25). The abutment was originally surrounded by a soil embankment protected by a retaining wall and concrete apron. Massive scour of all backfill and sand subsoil was observed below the collapsed reinforced concrete embankment apron, which led to the exposure of the piled foundation below. The maximum scour depth was approximately 4.5 m (15 ft), and the scour extended behind the abutment wall and undermined the approach slabs by as much as 2.5 m (8 ft). A combination of wave-induced liquefaction and shear-induced scour is also believed to be responsible for the complete failure of Beach Boulevard in Bay St. Louis, where the maximum scour depth was around 1.5–1.8 m (5–6 ft) (Fig. 26). A number of residential and low-rise commercial buildings also suffered foundation failure and partial building collapse due to undermining by scour (Fig. 27).

**Fig. 25.** Up to 4.5 m (15 ft) of scour around abutment exposing piles below abutment

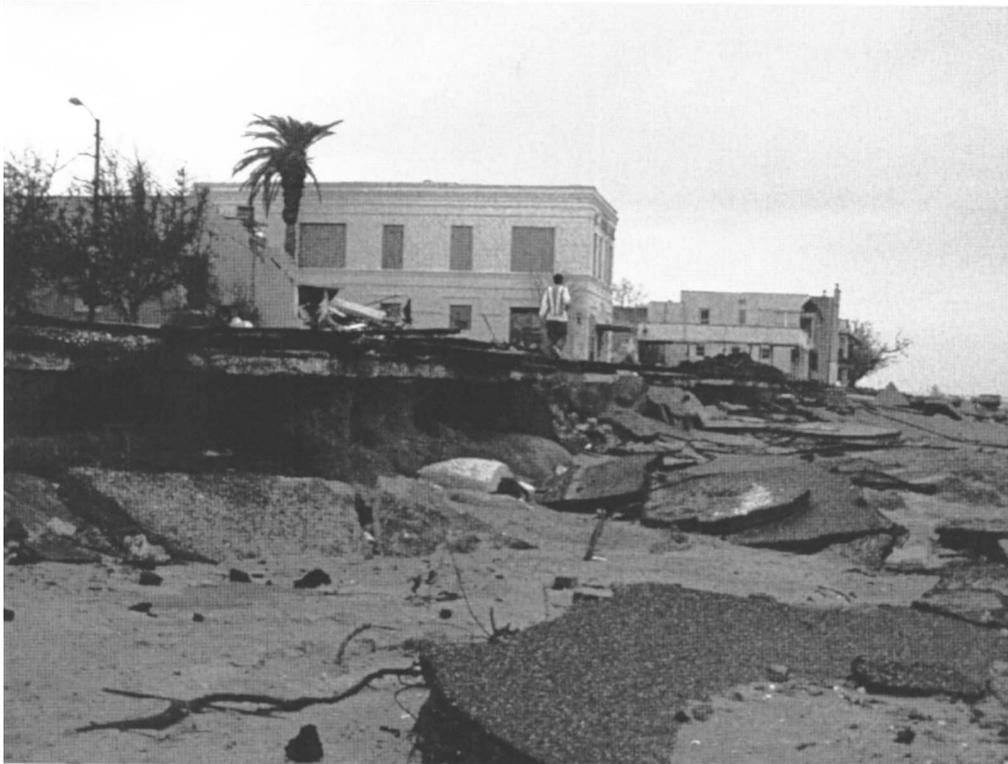
**Fig. 26.** Complete scour of Beach Boulevard in Bay St. Louis

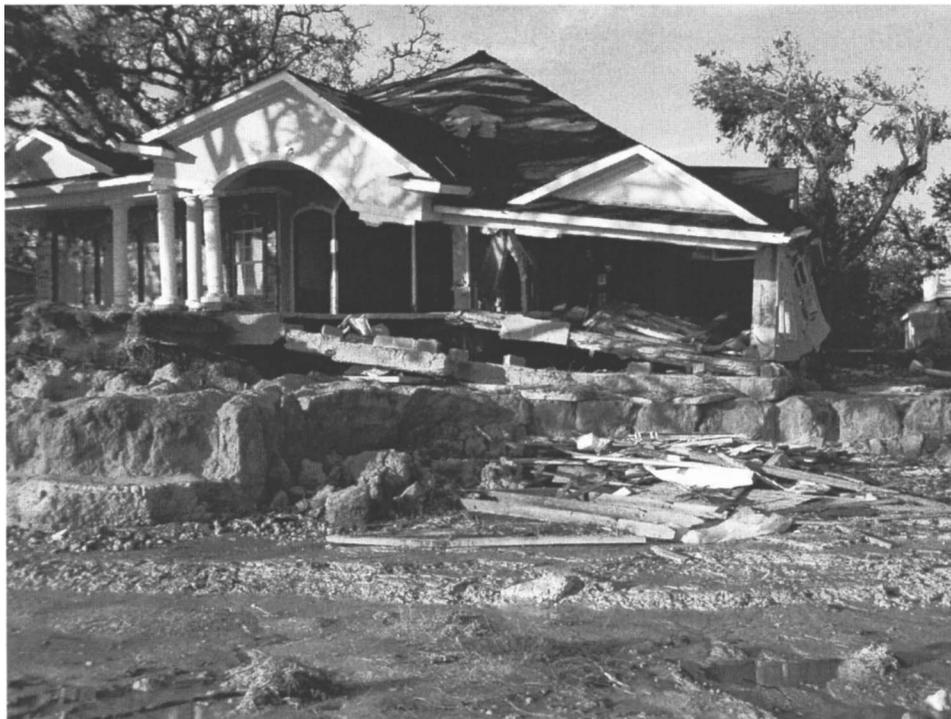
**Fig. 27.** Scour under foundations leading to partial collapse of residence

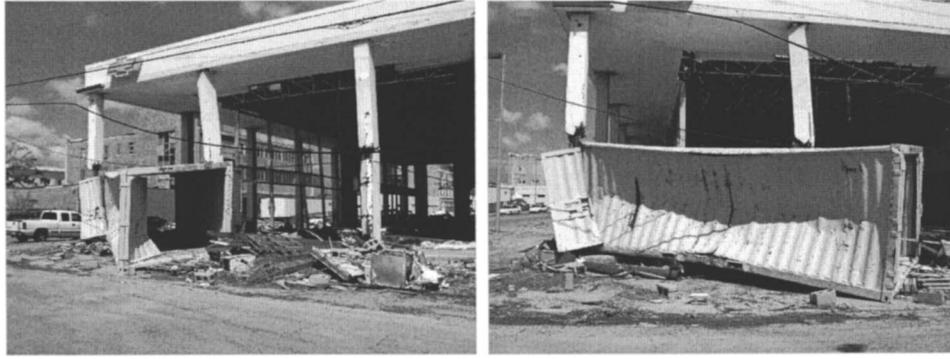
**Fig. 28.** Empty steel shipping container lodged against columns supporting roof

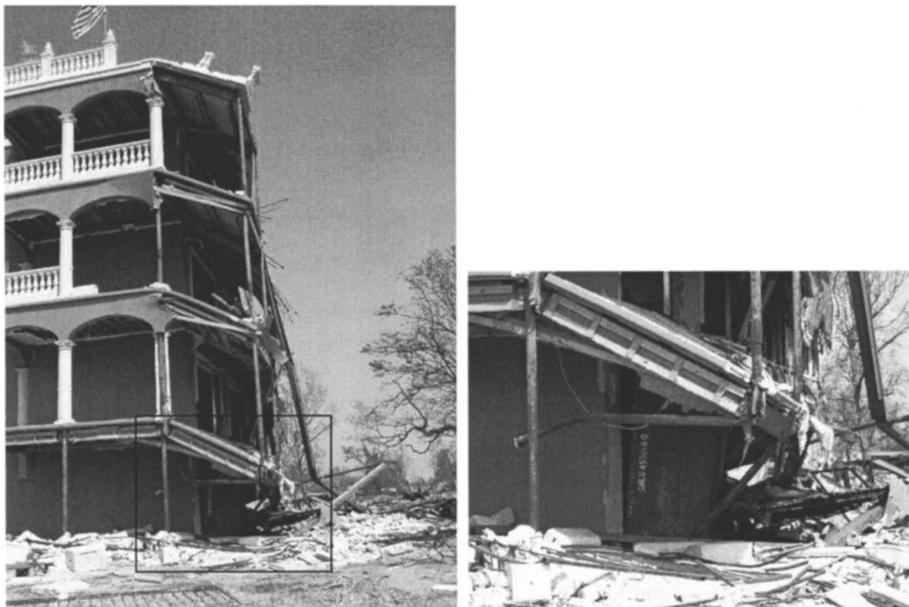
**Fig. 29.** Shipping container damage to steel pipe columns supporting balconies

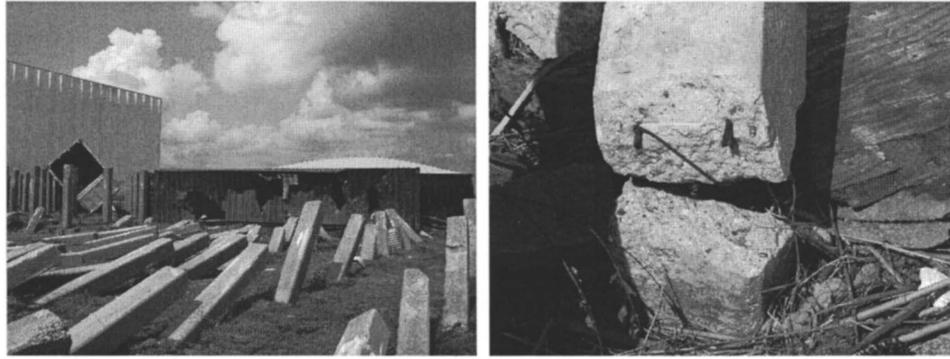
**Fig. 30.** Bending failure of piles due to shipping container impact and damming effect
