Construction and Testing of an Accelerated Bridge Construction Project in Boone County

This paper will present the construction process, construction schedule, and laboratory testing for one of the first applications of an accelerated bridge project utilizing precast components in the state of Iowa. Through the FHWA Innovative Bridge Research and Construction program, a bridge in Boone County, Iowa was constructed using several different precast, high-performance concrete elements.

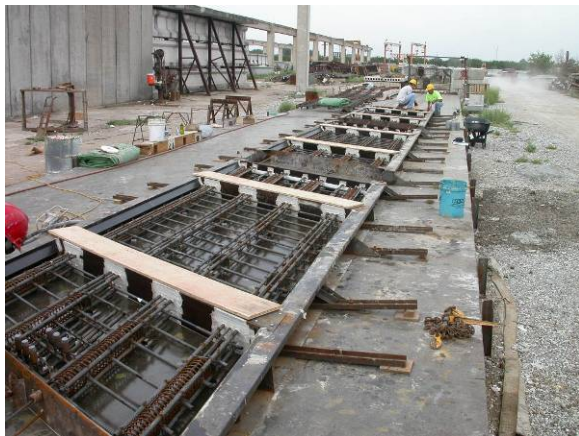
Figure 1. Panel forms and reinforcing

Three deck panels could be cast in one casting operation. Panels could be fabricated every other day with a maximum of nine panels cast per week. Andrews fabricated reusable steel forms shown in Figures 1 and 2; the panels were cast on a steel casting bed in the open.

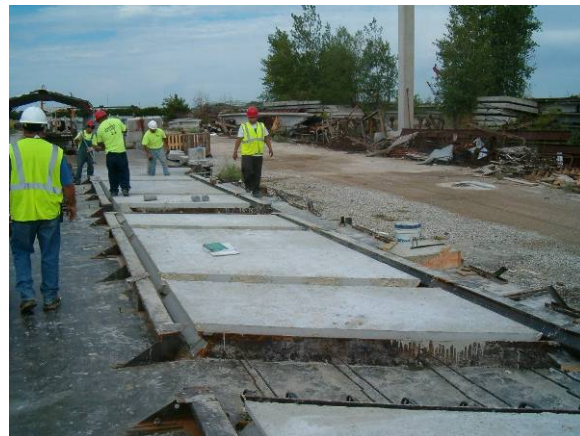
Figure 2. Panel form release

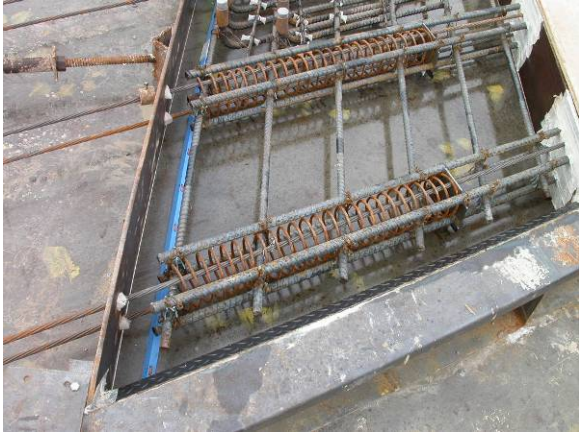
Figure 3. Spiral reinforcing

The anchorage zone was very short for the development of the pretensioning strands. Thus, spiral reinforcing was used to reinforce the bursting zone. Use of spiral reinforcement also improved strand development (see Figure 3). At the longitudinal centerline of the bridge, a longitudinal joint was cast in place. Reinforcement of the longitudinal joint was provided with double hairpin bars projecting from the panels, shown in Figure 4, and straight reinforcing bars threaded longitudinally. One benefit of a cast-in-place longitudinal joint at the centerline was to allow the panels to be cast flat and introduce the bridge crown in the longitudinal joint. The longitudinal joint at the centerline of the bridge did not add any construction time to the critical path because the longitudinal joint was cast concurrently with the open channels over the four beams after the post-tensioning.

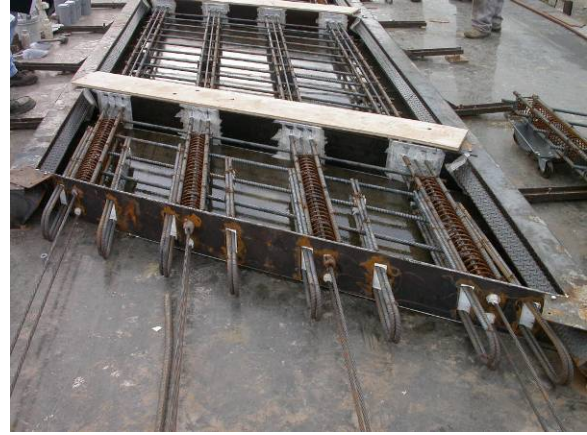
Figure 4. Longitudinal joint reinforcing

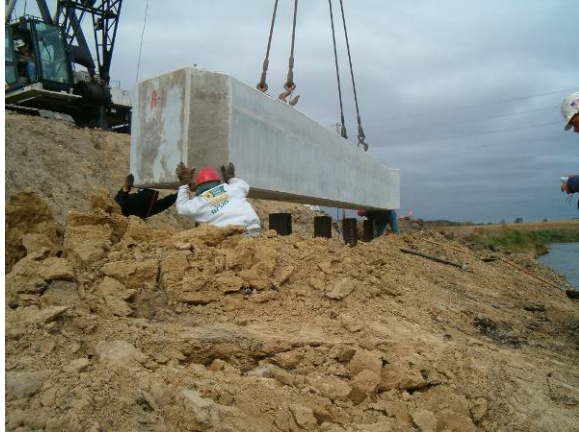
Figure 5. Setting precast abutment

Precast abutment caps and precast pier caps founded on H-piling and pipe piling, respectively, comprised the substructure. The units were reinforced with mild reinforcing and included blockouts for the piling that were created using corrugated metal pipe (CMP). During the design process, no research was found regarding the pile connection detail considering a bond or development of resistance between concrete and the CMP. A fairly conservative connection design was completed which was later validated by testing. The contractor had an end of driving tolerance of three in. in any direction for each H-piling in order to fit the precast abutment cap over the H-piling. Standard specifications typically only specify a start of driving tolerance for H-piling. Special plan notes were included to specify the end of driving tolerance. Care was taken during the pile driving operation, and the contractor had no problem meeting the end of pile driving tolerance or fitting the precast abutment cap over the H-piling shown in Figures 5 and 6; time required to set a single precast abutment cap was less than 30 minutes.

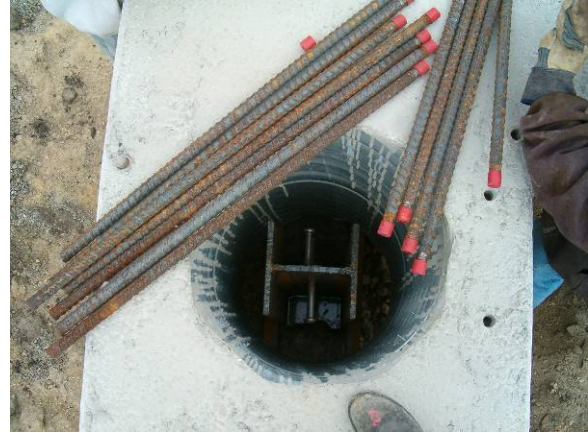
Figure 6. Abutment CMP blackout

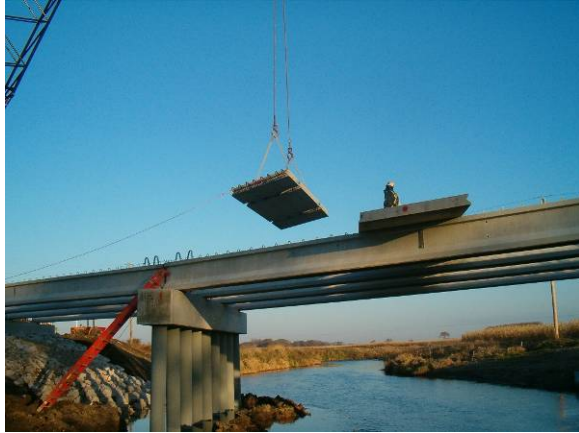
Figure 7. Deck panel erection

The first half of the deck panel erection took the whole day. Panels were erected from the centerline of the bridge working outward (see Figure 7). Erection of the second half of the panels took half of the day. The primary difficulty erecting the deck panels is the alignment of the first deck panel erected. Once the first panel is properly positioned, the remaining panels were uniformly offset 3/8 in. and maintained the correct alignment. Panel leveling devices were installed the same day the deck panels were erected, as shown in Figure 8.

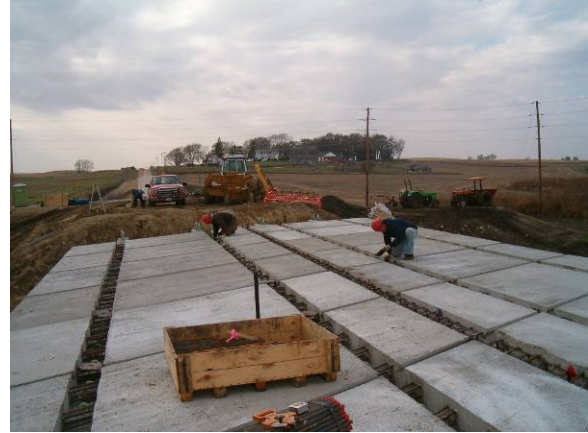
Figure 8. Leveling device installation

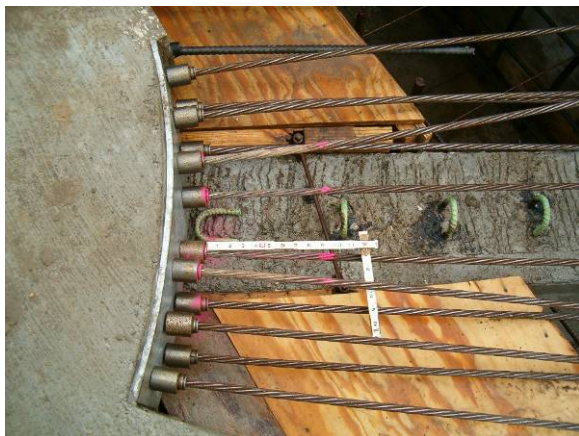
Figure 9. Strand elongation check

Post-tensioning forces were verified by calibrated gage pressure. Strand elongation was checked as a final confirmation, shown in Figure 9. The jack stroke length was monitored during post-tensioning as a safety precaution against over tensioning.

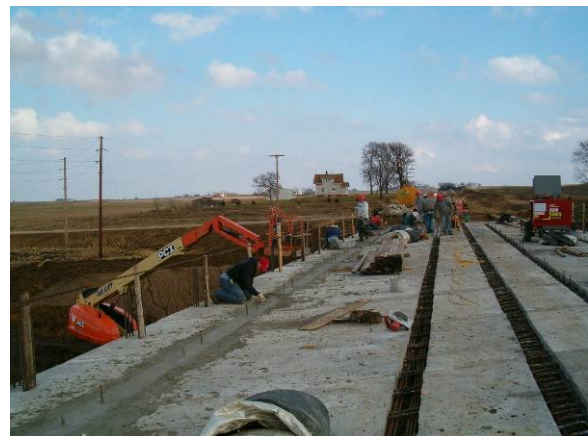
Figure 10. Casting longitudinal joints

Concrete was cast in the longitudinal joints on the same day the post-tensioning force was applied, shown in Figure 10. As shown in Figure 11, the same concrete mix used for the transverse joints was used for the longitudinal joints. The longitudinal joints were congested with post-tensioning strands, transverse mild reinforcing, transverse prestressing strands, stirrups, and leveling plates with leveling screws.

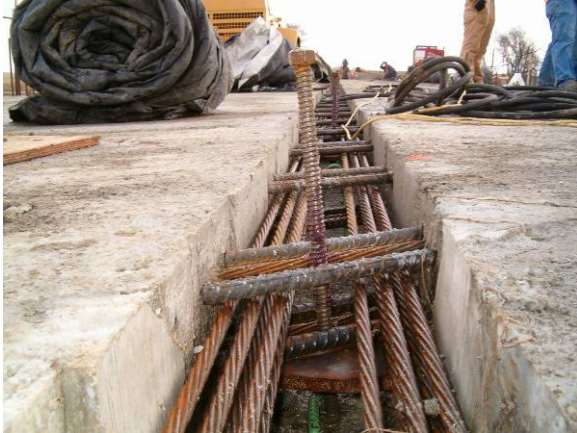
Figure 11. Channel congestion

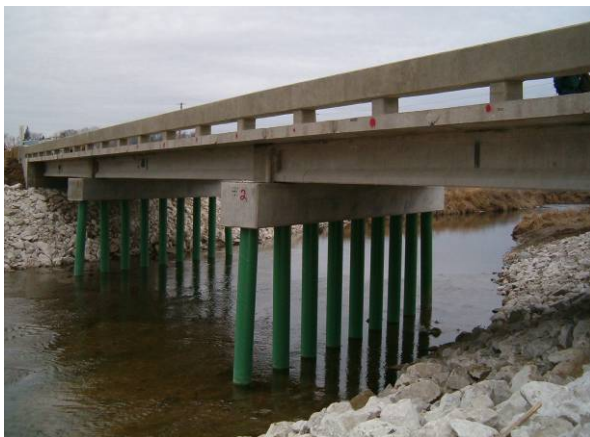
Figure 13. Bridge profile

To complete the bridge, the corral style barrier rail was cast in place, and the deck was ground for smoothness and grooved for texture prior to opening the bridge to traffic. Figures 13 and 14 show the completed bridge.

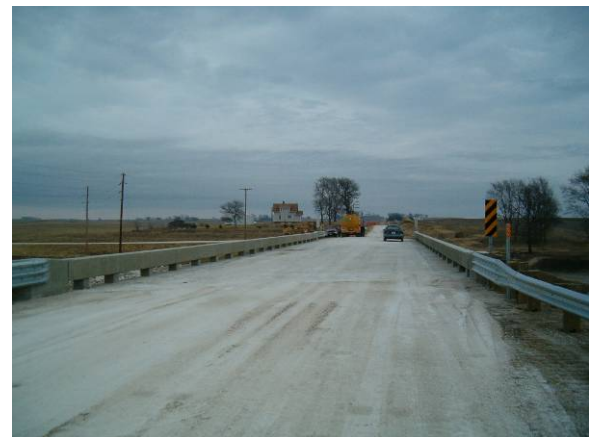
Figure 14. Bridge approach

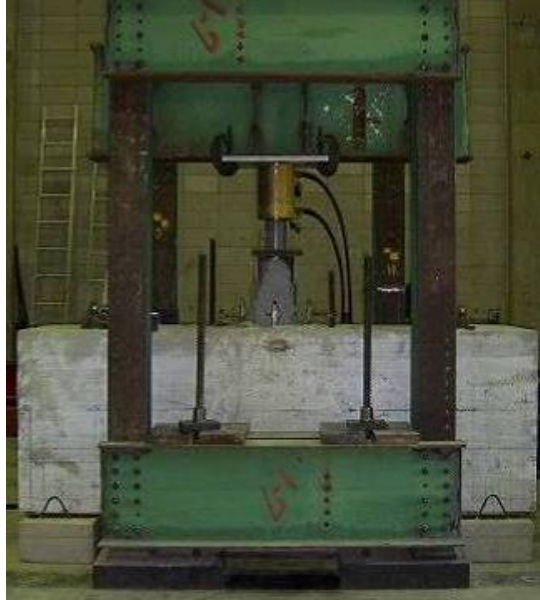
Figure 16. Laboratory testing system

Simulated beams were fabricated out of concrete and placed on the laboratory floor. Neoprene bearing pads were placed on top of the simulated beams, and the specimens were placed on the bearing pads. In this configuration, the pile extended upwards and was loaded from above. One of the test specimens, situated under the load frame prior to loading, is shown in Figure 16. Note the specimens were inverted for stability when tested.
