# Lessons from Hurricane Katrina Storm Surge on Bridges and Buildings

Ian N. Robertson<sup>1</sup>; H. Ronald Riggs<sup>2</sup>; Solomon C. S. Yim<sup>3</sup>; and Yin Lu Young<sup>4</sup>

**Abstract:** The storm surge associated with Hurricane Katrina caused tremendous damage along the Gulf Coast in Louisiana, Mississippi, and Alabama. Similar damage was observed subsequent to the Indian Ocean tsunami of December 26, 2004. In order to gain a better understanding of the performance of engineered structures subjected to coastal inundation due to tsunami or hurricane storm surge, the writers surveyed damage to bridges, buildings, and other coastal infrastructure subsequent to Hurricane Katrina. Numerous lessons were learned from analysis of the observed damage, and these are reported herein. A number of structures experienced significant structural damage due to storm surge and wave action. Structural members submerged during the inundation were subjected to significant hydrostatic uplift forces due to buoyancy, enhanced by trapped air pockets, and to hydrodynamic uplift forces due to wave action. Any floating or mobile object in the nearshore/onshore areas can become floating debr

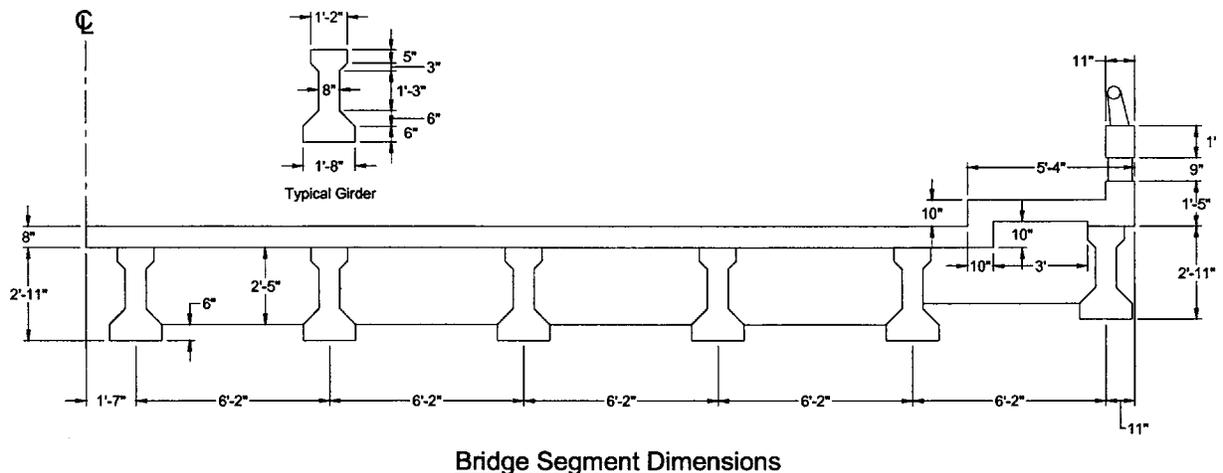
The US 90 highway bridge over Biloxi Bay is composed of simply supported bridge segments varying in length from 13.7 to 15.9 m (45 to 52 ft), each consisting of six prestressed concrete girders supporting half of the roadway deck and one sidewalk. The air trapped between the girders, along with the reduction in self-weight due to submersion in seawater, meant

**Fig. 4.** Cross-section details of US 90 highway bridge over Biloxi Bay (1 ft=0.3048 m)

that these segments were very nearly buoyant once submerged (Fig. 3). Fig. 4 shows the dimensions of a typical cross section of the bridge deck as measured on site, and Fig. 5 outlines the buoyancy calculation performed on this cross section, including the effects of air compressibility.

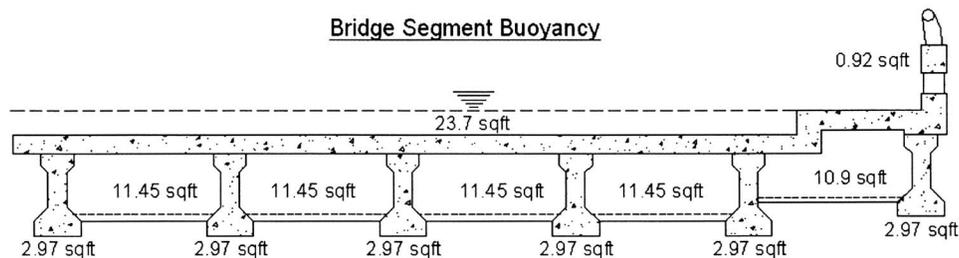
Fig. 5. Buoyancy calculation for US 90 highway bridge over Biloxi Bay (1 ft=0.3048 m, 1 lb=4.445 N)

The buoyancy analysis results based on in Fig. 5 for the US 90 highway bridge across Biloxi Bay are summarized in Table 3 along with those for six other bridge cross-sections measured during the reconnaissance trips. These calculations are based on a unit length of the bridge cross section. The bridge deck self-weight is also listed in Table 3 as a weight per unit length of the bridge cross section, based on field measurements of each

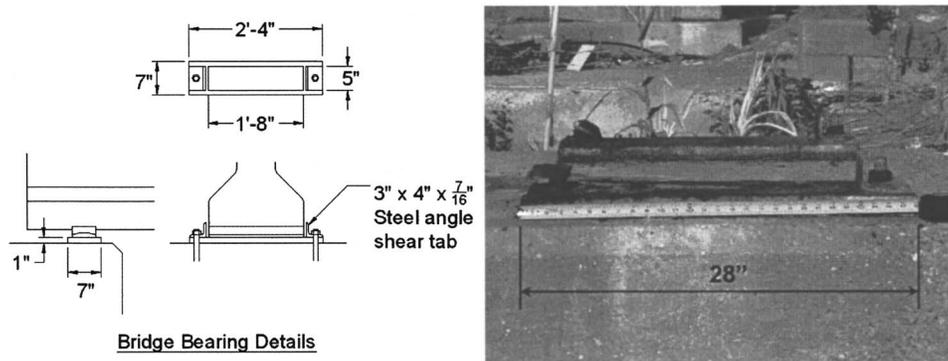
For the US 90 highway bridge across Biloxi Bay, the bearings supporting each end of the girders at the pier bents provided no restraint against uplift and only nominal resistance against lateral movement (Fig. 6). Being a low seismic zone, the region had no requirements for shear keys to provide lateral restraint or ties to prevent uplift, as is common in seismic regions. Friction induced by gravity load, and small 11 mm (7/16 in.) thick steel angles, were the only physical restraint against lateral movement for these bridge segments. When subjected to the wave-induced hydrodynamic uplift (Table 2) and/or buoyancy effects (Table 3), the segments were free to move off their supports under the lateral load from surge and wave action (Table 1). Apart from the bridge segments elevated over the ship channel, every segment of this bridge was dislocated from its supports and collapsed into the bay.

Fig. 6. Bearing restraint details for US 90 highway bridge over Biloxi Bay (1 in.=25.4 mm)

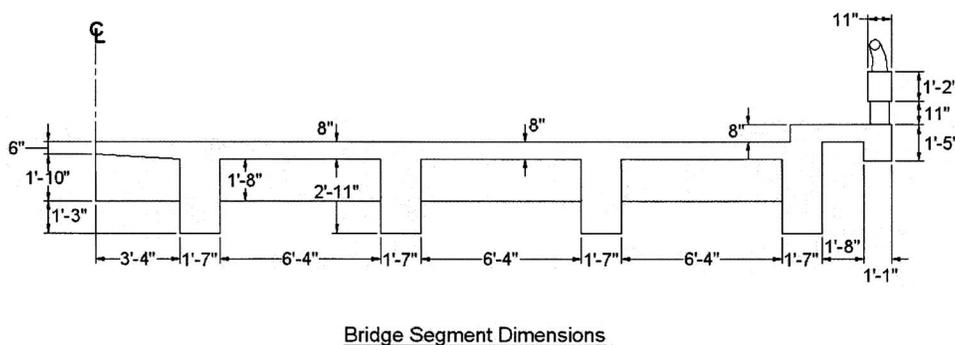
Even bridges with significant residual self-weight when submerged suffered failures due to inadequate shear keys to prevent lateral movement of the bridge deck segments. For example, the US 90 highway bridge across Bay St. Louis had a residual dead weight of 23.3% when fully submerged (Table 3). The bulkhead and bridging elements provided between the girders of this deck are only partial depth (Fig. 7), allowing much of the air below the deck to escape. Nevertheless, virtually every segment of this bridge was dislodged from the supporting piers. These failures are attributed to the additional effects of hydrodynamic uplift (Table 2) and lateral loads from surge and wave action (Table 1), combined with the lack of restraint against uplift or lateral movement at the support bearings. Fig. 8 shows the rocker bearing at one end of each span. The only restraint against lateral movement of the girders was the three small shear studs provided between the rocker and the bearing plate in the girder soffit.

Fig. 7. Cross-section details of US 90 highway bridge over Bay St. Louis (1 ft=0.3048 m, 1 in.=25.4 mm)

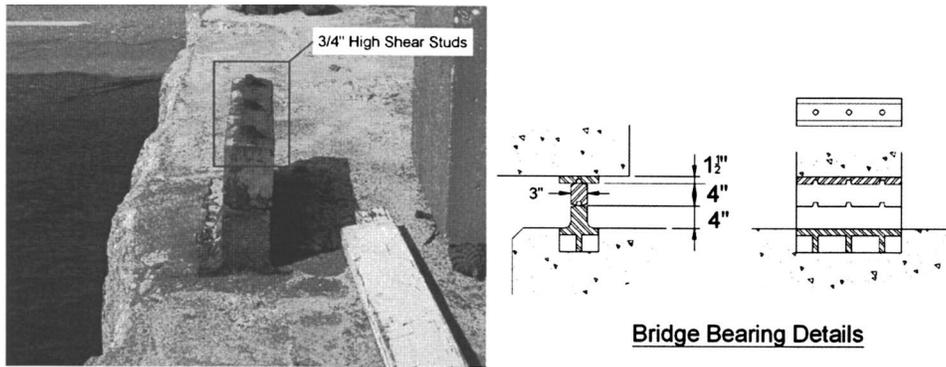
**Fig. 8.** Rocker bearing details at US 90 highway bridge over Bay St. Louis (1 in.=25.4 mm)

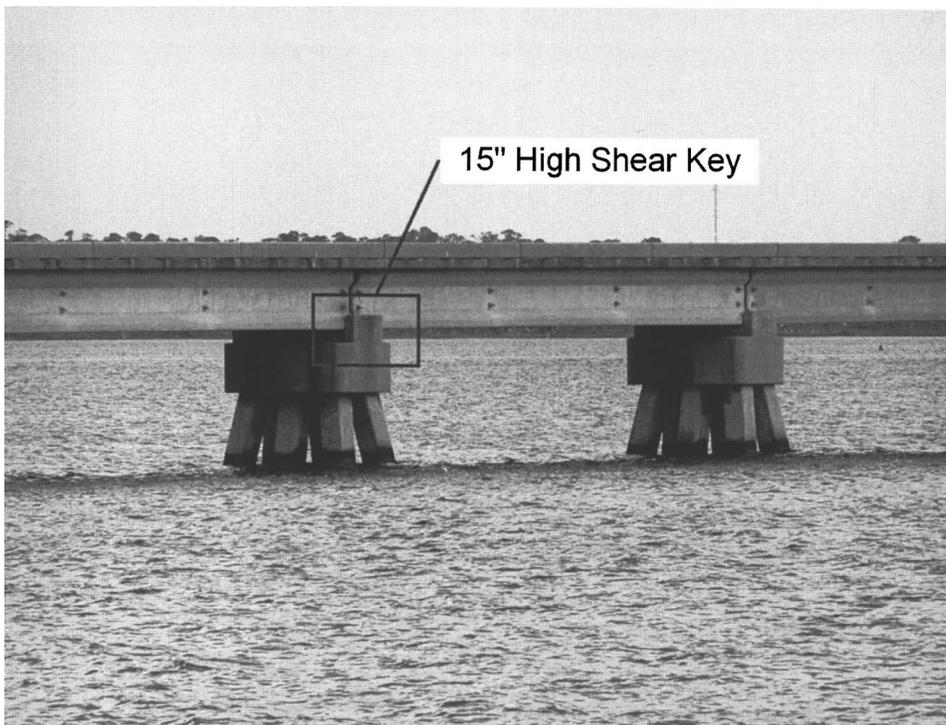
In addition, the superior lateral restraint provided by 380 mm (15 in.) high concrete shear keys on either side of the girders at each support pier (Figs. 9 and 10), was sufficient to resist the lateral hydrodynamic loads (Table 1). Not a single segment of this bridge collapsed.

**Fig. 9.** Railroad bridge over Biloxi Bay with close-spaced girders and large concrete shear keys (1 in.=25.4 mm)

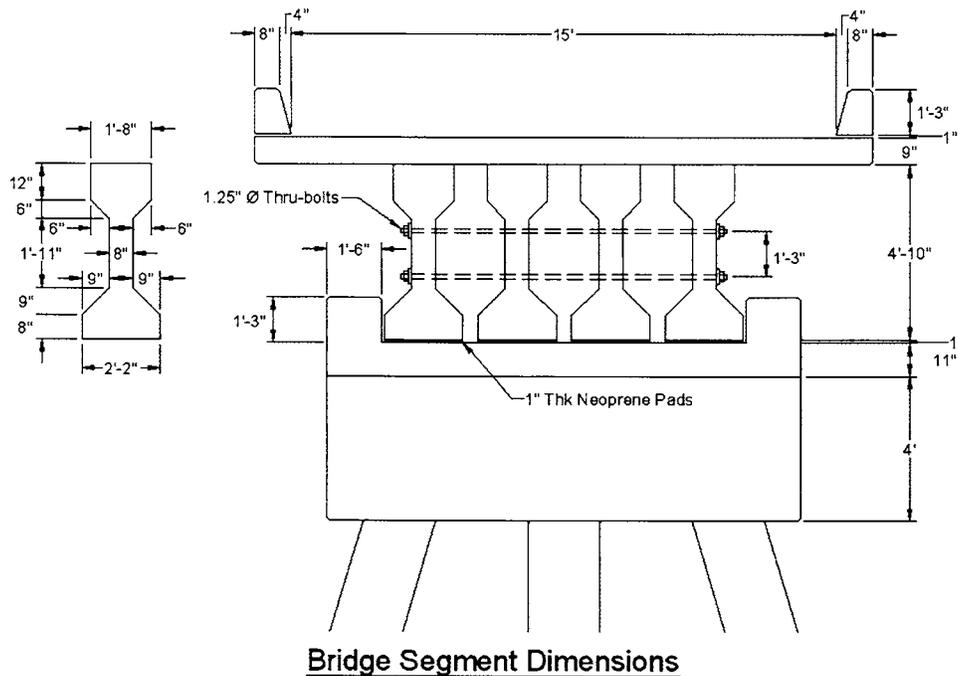
**Fig. 10.** Cross-section details of railroad bridge over Biloxi Bay (1 ft=0.3048 m)

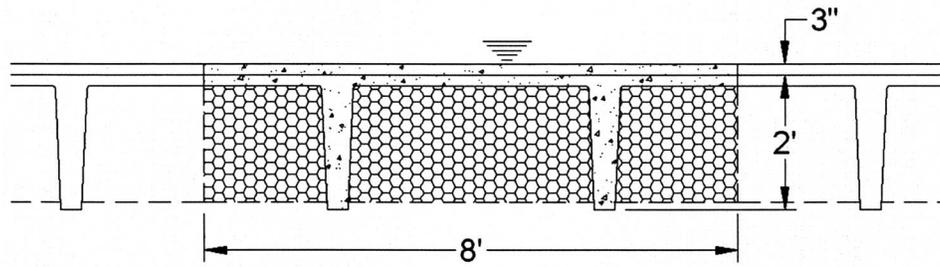
The elevated floors of these precast parking structures consist of prestressed concrete double-tee girders supporting a 50 to 75 mm (2 to 3 in.) thick cast-in-place concrete topping slab. Significant uplift resulted from buoyancy of air trapped between the girder webs below the floor deck (Fig. 12). This air could not escape because of the supporting inverted T-beams or spandrel beams at either end of the span. In addition, the cast-in-place topping slab covers the joint between adjacent double-tees and any gap between the double-tee and the supporting elements at either end of the span. Unable to escape, the air below the floor slab induced uplift well in excess of the submerged dead weight of the double-tee plus topping, resulting in significant negative bending (hogging) of the precast sections.

inspected garages, with the larger topping thickness of 75 mm (3 in.), the net uplift due to buoyancy exceeds 50% of the original dead weight in air. In other words, the buoyancy due to submersion in seawater and the effect of entrapped air results in a total hydrostatic uplift of 153% of the original dead weight of the section. For deeper and wider sections with thinner topping, this uplift increases to as much as 191%. The situation would be even worse if any of the double-tees and/or topping slabs were constructed of lightweight concrete.

Fig. 12. Volume of air potentially trapped below a single double-tee girder (1 ft=0.3048 m)

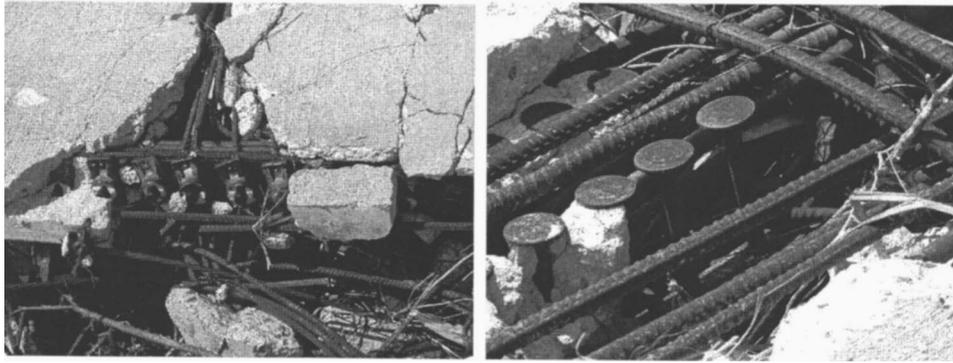
**Fig. 17.** Posttensioned anchors at slab edge and headed stud shear reinforcement at slab-column connection
