Development of Machine Vision Technology for Railcar Safety Appliance Inspection

Summary: Before North American trains depart a terminal or rail yard, many aspects of the cars and locomotives undergo inspection, including their safety appliances. Safety appliances are handholds, ladders and other objects that serve as the interface between humans and railcars during transportation. The current inspection process is primarily visual and is labor intensive, redundant, and generally lacks "memory" of the inspection results. The effectiveness and efficiency of safety appliance inspections can be improved by use of machine vision technology. This paper describes a research project investigating the use of machine vision technology to perform railcar safety appliance inspections. Thus far, algorithms have been developed that can detect deformed ladders, handholds, and brake wheels on open-top gondolas and hoppers. Visual learning is being used to teach the algorithm the differences between safety appliance defects that require immediate repair, and other types of deformation that do not. Field experiments under natural and artificial lighting have been conducted to determine the optimal

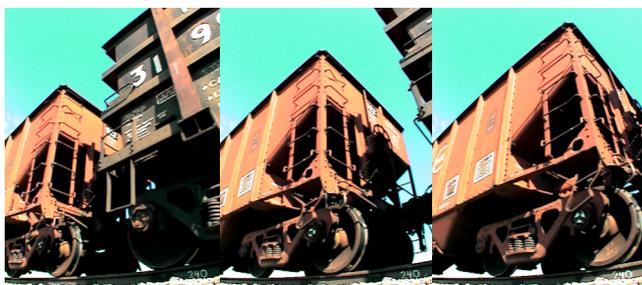
Frames are generated at a rate of 30 frames per second and are converted to an AVI format. This frame rate ensures that at least one image will be captured within the tolerance window of ± 20 pixels relative to the center of the image (Fig. 1).

Figure 1. Image sequence for one corner of a railcar showing, A) an image taken too early, B) at the optimal time, and C) too late

defects, non-FRA deformation, or no deformation. From the input video it is first necessary to select an optimal frame that provides the best view of a car passing by the camera. Note that in a video sequence the position of the moving car is displaced in each consecutive frame by a small but not necessarily constant amount. In the optimal frame (Fig. 1), the car position is such that the car's two top edges meet at the center of the image.

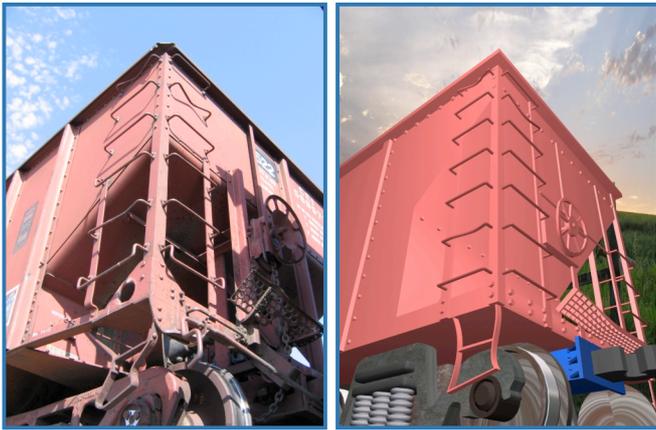
Autodesk's® 3DS MAX 8 computer modeling software was used to create a three-dimensional model of an open-top hopper car. 3DS MAX allows the user flexibility in depicting different camera views and angles, as well as in depicting realistic lighting conditions. Additionally, the program provides a means of generating both still images and AVI files of the railcar model. A comparison of an actual camera and an image from the 3D model is shown in Figure 5.

Figure 5. Views of a railcar with deformed safety appliances (left) and the corresponding 3D model showing the deformation (right)

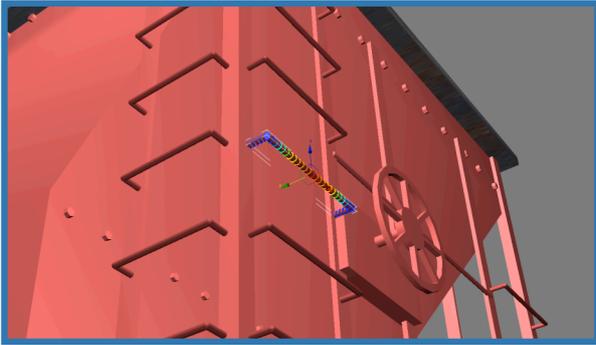
An algorithm was developed that dynamically modifies the car model to represent typical safety appliance defect types. The algorithm is fed the two extremes of a given type of safety appliance deformation and incrementally generates images of deformation that fall between the two extremes (Fig. 7). This is being used to generate a large number of systematically varied images that are being used to train the learning algorithms.

Figure 7. Virtual car model image indicating how deformation will be used to systematically create a library of deformations of a ladder rung

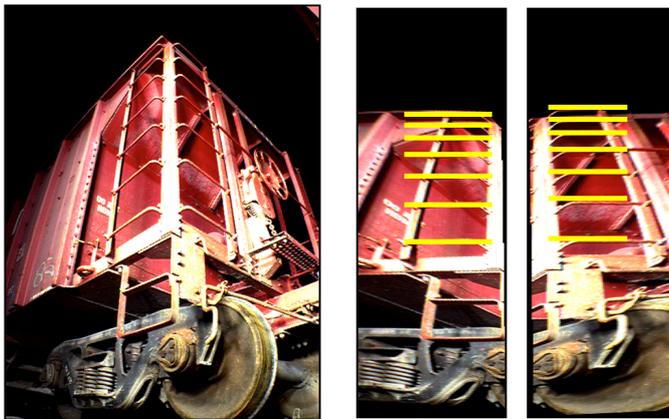
Figs. 9 shows the artificially illuminated railcar and the algorithm results. The tests were repeated with railcars of differing color. The final configuration had the fewest shadows and gave satisfactory image recording and detection results. The results of the nighttime illumination tests will be used as the basis for design of a semi-permanent machine-vision installation currently being planned.

Figure 9. A) Nighttime image of BL corner of railcar illuminated by six 1,000-Watt lights B) foreshortened view with algorithm identification of ladder rungs
