# Machine Vision Condition Monitoring of Heavy-Haul Railcar Structural Underframe Components

**Summary:** Monitoring the structural health of heavy-haul rolling stock is critical to ensuring safe and efficient railroad operation. As a result, periodic manual inspections are required to detect structural damage and defects. These inspections rely heavily on the acuity, knowledge and endurance of qualified inspection personnel. There is the potential to enhance inspection effectiveness and efficiency through machine vision technology, which uses computer algorithms to convert digital image data into useful information. This paper describes research and development of an automated machine vision inspection system capable of detecting structural defects in freight car underframes.

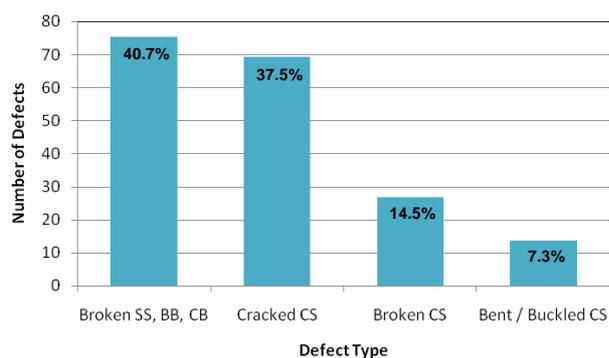
**Average Defects Per Year (2000-2007)**

Figure 1: Average number of structural defects recorded by FRA Motive Power and Equipment inspectors per year

Inspection data from the FRA Office of Safety from 2000 to 2007 shows that on average 59% of structural component defects are comprised of broken, cracked, bent, or buckled center sills

(CS), while the remaining 41% represent defective sidesills (SS), body bolsters (BB), or crossbearers (CB) (Figure 1). Based on these data and guidance from the AAR, the primary focus of AISC is inspecting the center sill and the secondary focus is the inspection of other structural components. All these components, although infrequently defective, are critical to the structural integrity of the freight car.

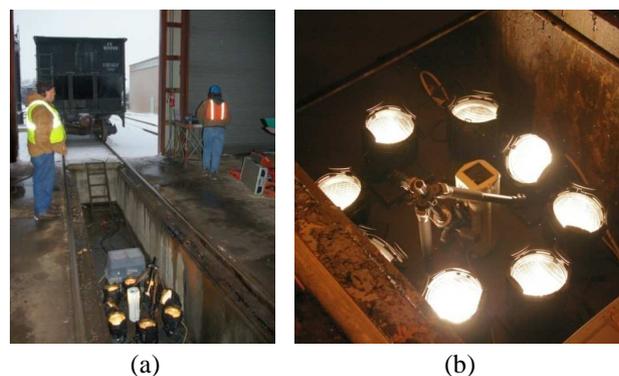
Figure 2: Experimental set-up at Monticello (a); lighting and camera arrangement in the pit (b)

Initial tests were conducted at the Monticello Railway Museum in Monticello, IL on an Illinois Central, 1950 era AAR-standard-design hopper car. The car was rolled over a locomotive repair pit while recording videos using various lighting arrangements (Figure 2).

The camera and lighting arrangement was placed at the bottom of the three-foot pit, and data were acquired via a laptop computer adjacent to the tracks. Videos were taken at varying train speeds and lighting conditions, and a panoramic image was developed from the video data (Figure 3).

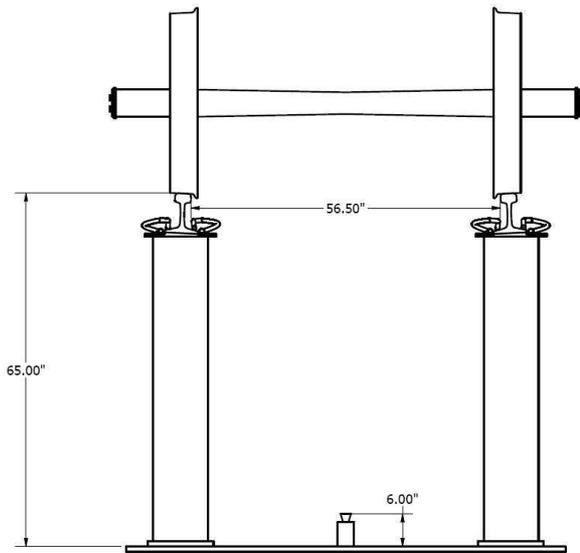
Figure 4: Equipment set-up showing 90° straight-up view

After analyzing the preliminary image acquisition results and subsequent data collected using portable image acquisition carts, an

experimental set-up was developed (Figure 4) and data collection procedures were defined.

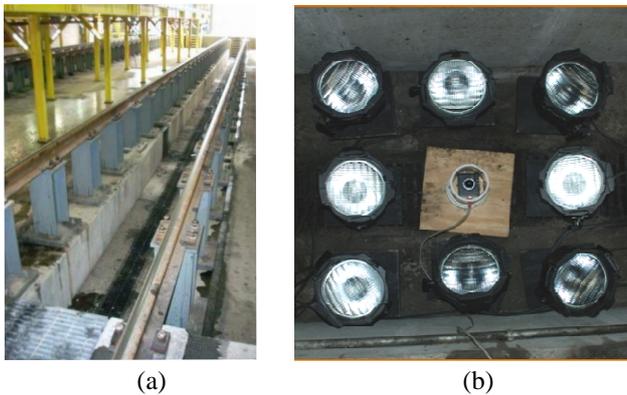
Figure 5: Locomotive repair pit used for data collection (a); camera and lighting set-up (b)

This equipment arrangement was used during testing at a Norfolk Southern locomotive repair facility in Decatur, IL (Figure 5).

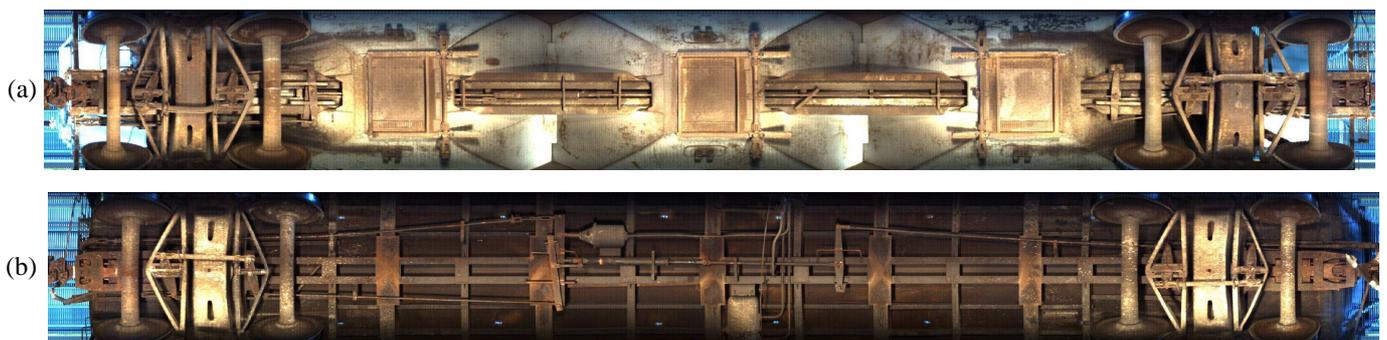
Figure 6: Panoramic images of hopper car (a) and gondola car (b) taken from NS locomotive repair facility in Decatur

Tests were run on several different railcars by rolling them above the camera at 3-5 mph. As before, the videos were developed into panoramic images (Figure 6). Results from the testing at Decatur show much more even illumination for the hopper car image (Figure 6a) as compared to the previous hopper panorama (Figure 3). Only the center strip of each individual video frame is extracted to develop the panorama, so improvements were made by focusing illumination at the center of the image. The panorama of the gondola underbody (Figure 6b) provides a clear view of the center sill, crossbearers, and crosssties (the thinner lateral members between the crossbearers).

Other components of the gondola are also clearly visible including the brake reservoir, brake cylinder, and the entire foundation of the braking system. In order to determine the resolution of the panoramic images, engineering drawings were acquired from Norfolk Southern for each of the cars that were tested. By measuring the length of components in the panoramic image in pixels and dividing by the actual lengths of the components, the pixel-to-foot ratio (i.e. the image resolution) was determined to be 92.3 pixels per foot.

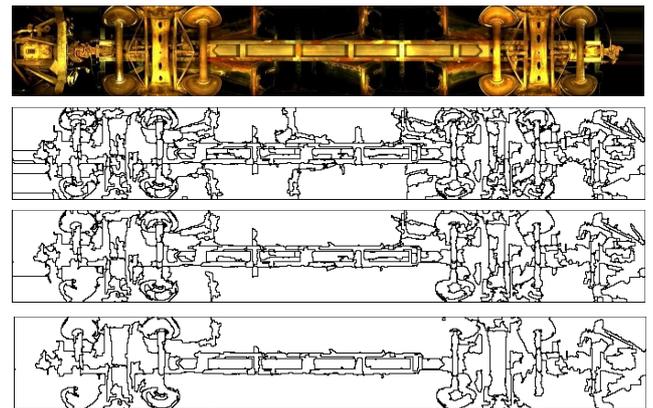
Figure 7: Multiscale segmentation hierarchy of the hopper car image showing the car underbody with the segmentation scale increasing from top to bottom

The segmentation algorithm partitions the image into homogeneous regions of previously unknown shape, size, gray-level contrast, and topological context. A region is perceived to be homogeneous if variations in pixel intensity within the region are smaller than intensity variations of its surroundings, regardless of its absolute degree of variability. Consequently, image segmentation may be performed at a range of homogeneity values (Figure 7).

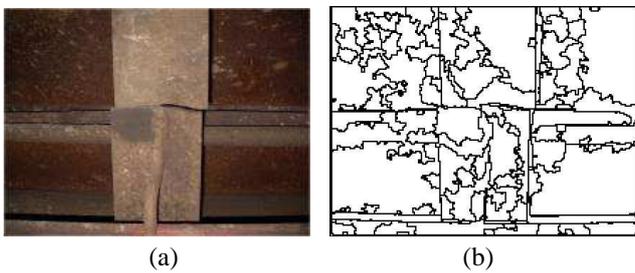
Figure 8: Digital picture of a broken crossbearer (a) with a fine-scale segmentation of the image (b)

obtains strictly constant intensity regions, yielding a multiscale segmentation of the image. As the scale increases, smaller regions strictly merge to form a larger region, which means that the segmentation algorithm is hierarchical. The same multiscale segmentation algorithm can also be used for simultaneous inspection of other structural components in addition to the center sill. For example, analyzing the image segmentation at a finer scale than that used for center sill inspection, crossbearers can also be inspected for breaks, cracks, bending and buckling (Figure 8).

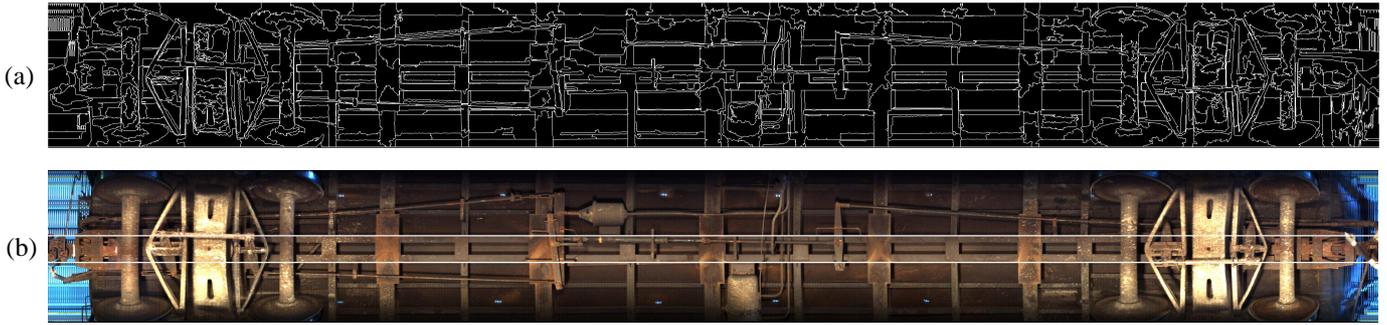
Figure 10: Edge image of gondola car underbody panorama (a) and original panorama with center sill detected (b)

An alternative, less computationally intensive method could be used to find the central location of the center sill. This method, based on pixel summation, is carried out by summing the pixels longitudinally for each row of the segmented image (or edge image) of the car panorama. Along each row in the edge image (Figure 10a) we compute the number of pixels present (i.e., pixels belonging to longitudinal edge lines in the image). Prominent peaks in the histogram of the pixel summation denote long, straight sections in the image (Figure 11). Since the center sill creates the longest edges in the panoramic image, the two largest peaks (rows 276 and 388) correspond to the outer contours of the center sill, while the four interior peaks correspond to the inner contours of the center sill. The outer contours of the center sill are then denoted with parallel lines (Figure 10b).

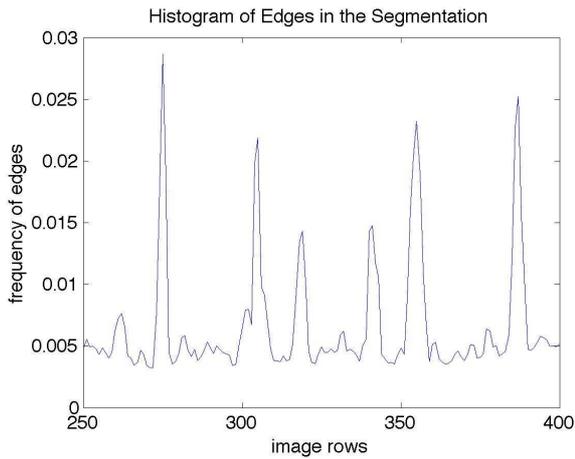
Figure 11: Histogram of the pixel summations belonging to region boundaries

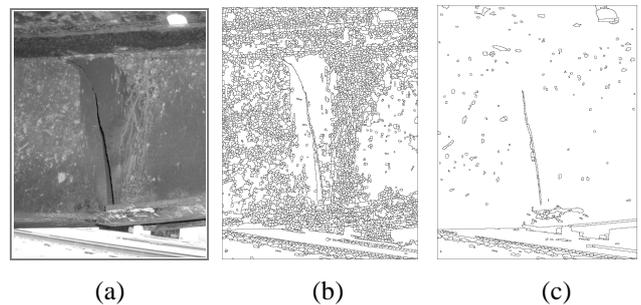
Figure 12: Original digital image of a crack (a), and fine to coarse segmentation images, from multiscale segmentation, showing good isolation of a crack to be identified (b) and (c)

breaks. This phase of work is still in preliminary stages, but a multiscale process has been proposed as a potential approach to this aspect of inspection. Both cracks and breaks can be modeled as distinct objects that may occur in the image area occupied by the center sill. A crack can be modeled as a homogeneous, elongated region that appears darker than the center sill. Similarly, a break can be modeled as a dark region that represents a discontinuity in the following properties of the center sill: brightness, contiguity of the sill's contours, and co-linearity and parallelism with parts of the center sill's contours. To identify breaks and cracks, a multiscale strategy will be used that recursively searches smaller subregions embedded in the region occupied by the center sill, and contrasts them against models of breaks and cracks (Figure 12).
