Machine Vision Condition Monitoring of Heavy-Axle Load Railcar Structural Underframe Components

*Submitted: Journal of Rail and Rapid Transit, Proceedings of the Institute of Mechanical
Engineers Part F, The Journal for Railway Engineering*

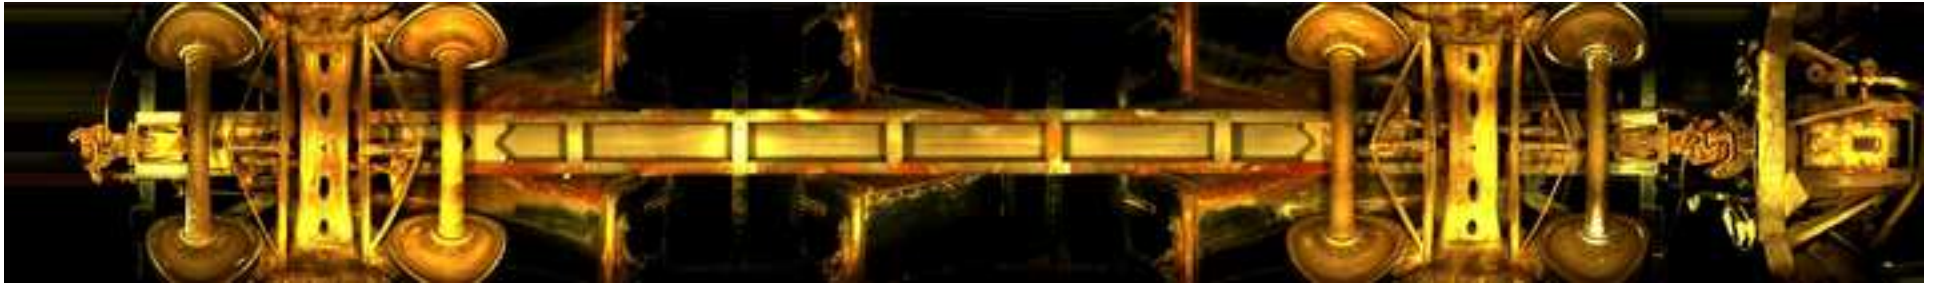
Figure 2
[Click here to download high resolution image](#)

Fig. 2 Panorama of hopper car underframe using preliminary image acquisition methods

portions of each consecutive video frame were extracted and appended together to form a complete image of the entire railcar underbody [9] (Fig. 2).

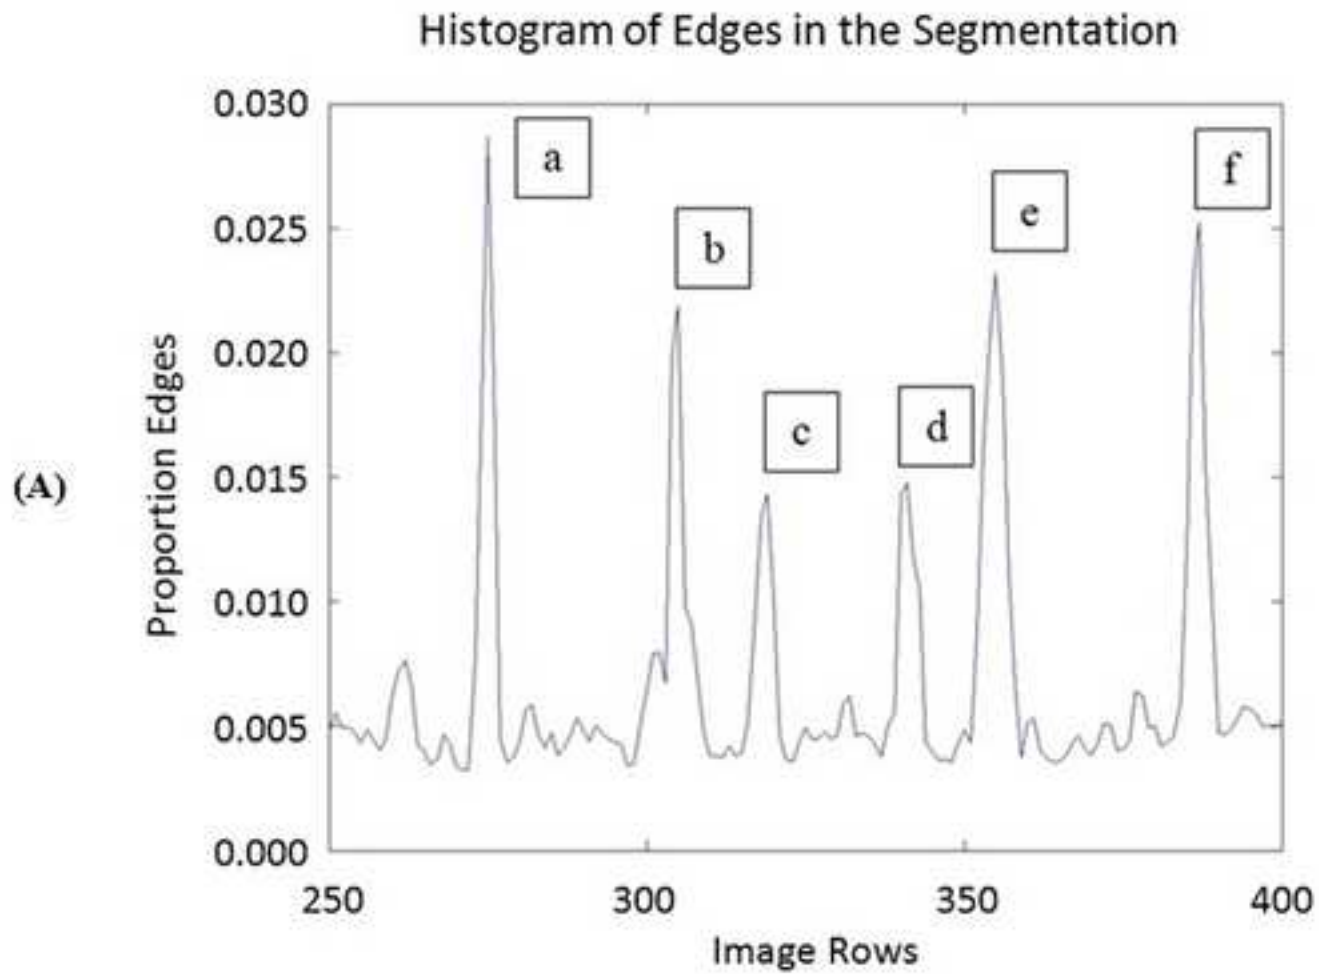
Figure 8
[Click here to download high resolution image](#)

Fig. 8 Histogram of the pixel summations belonging to center sill region boundaries, with the row index of the image on the horizontal axis and the proportion of strong edges on the vertical axis (A); (B) is a close-up of Fig. 7B, showing the edges (a - f) corresponding to (A)

An alternative, less computationally intensive method can also be used to find the location of the center sill. This method, based on pixel summation, is carried out by summing the pixels longitudinally for each row of the segmented image (or edge image) of the car panorama. The number of pixels along each horizontal row is computed from the edge image (Fig. 7A). Long, straight sections in the panoramic image will appear as prominent peaks in the histogram of the pixel summation (Fig. 8A).

Since the center sill creates the longest edges in the panoramic image, the two largest peaks (a and f in Fig. 8A) correspond to the outer contours of the center sill, while the four interior peaks (b - e in Fig. 8A) in the histogram correspond to the inner contours of the center sill (see Fig. 8B). The outer contours along the length of the center sill are then denoted with white parallel lines (Fig. 7B and Fig. 8B). These detected edges can then be used to guide the search for the remaining parts of the center sill as described in the previous method. Once the contours of the center sill are identified, they are compared with the ideal template. Any deviation from the parallel lines is interpreted as deformation. This method can also be applied in the lateral direction to identify and inspect crossbearers and crossies.

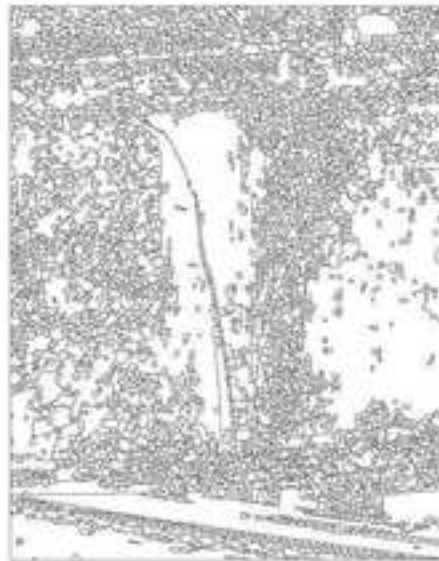
Figure 9
[Click here to download high resolution image](#)

Fig. 9 Original digital image of a cracked center sill, provided courtesy of AAR (A) and fine to coarse segmentation images (B-F), showing the crack at various segmentation levels

The algorithm will first identify the region that delineates the boundary of the center sill (Fig. 6A). To identify breaks and cracks, a multi-scale search strategy will be used that recursively searches smaller subregions embedded in the region occupied by the center sill. At each segmentation scale, the regions found will be compared to the models developed for breaks and cracks, identifying suspect regions corresponding to a center sill crack (Fig. 9).
